BRIDGE CHAPEL & CHAMBER REFURBISHMENT

HISTORY

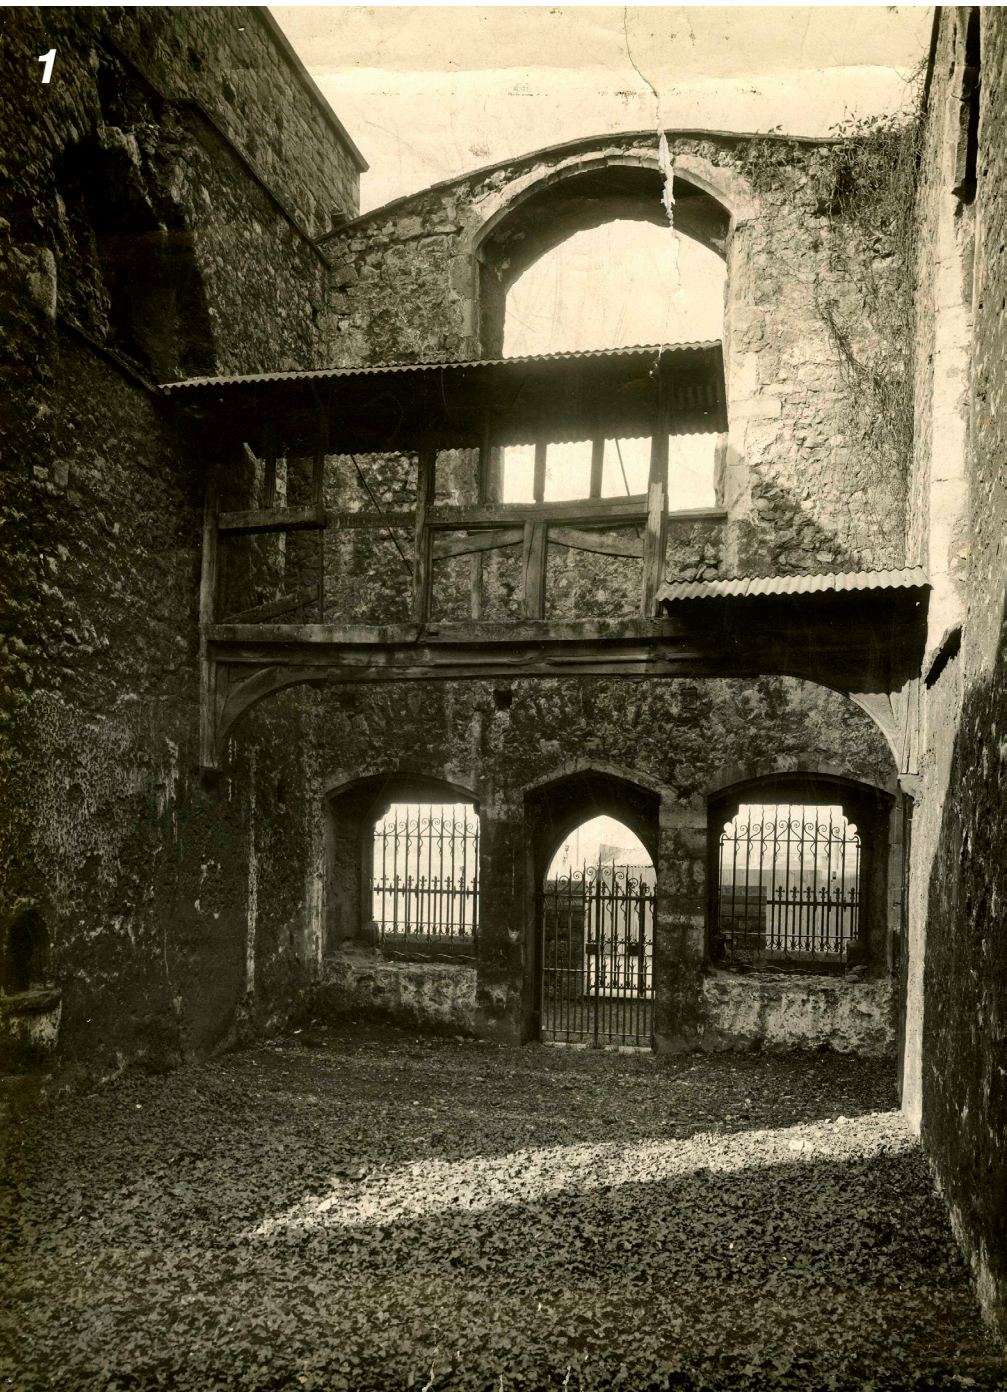
Images **1** Archive photograph of the Chapel in ruin. The photograph is dated from 1928 and demonstrate the significant extent of the reconstruction which took place a few years later in 1937 **2** Photo showing the porch to the Chapel (1877) following the demolition of the Waterman’s Arms to the right hand side of the Bridge Chamber **3-4** Views of the Chamber first floor main landing showing water damage to the interior walls and the delaminating stone floor in the small ground floor lobby
